ENGINEERING TEST REPORT

Sangoma Technologies Corp.
MODEL NO.: A102d

TIA-968-A
TECHNICAL REQUIREMENTS FOR
CONNECTION OF TERMINAL EQUIPMENT
TO THE TELEPHONE NETWORK

UltraTech FILE NO.: SNG31-ACTA

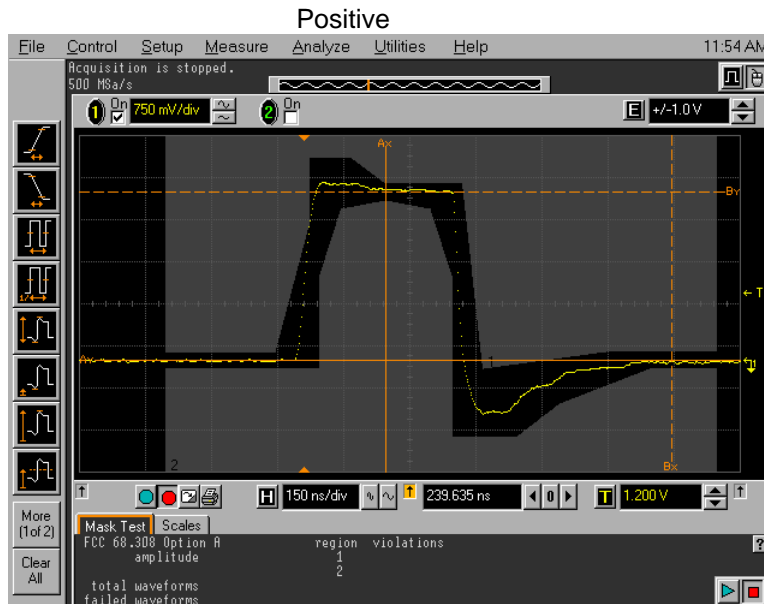
3.1.1. Before stress

3.1. OPTION A

Please refer to the oscilloscope traces in Exhibit 3 for details of conformance with the defined pulse mask.

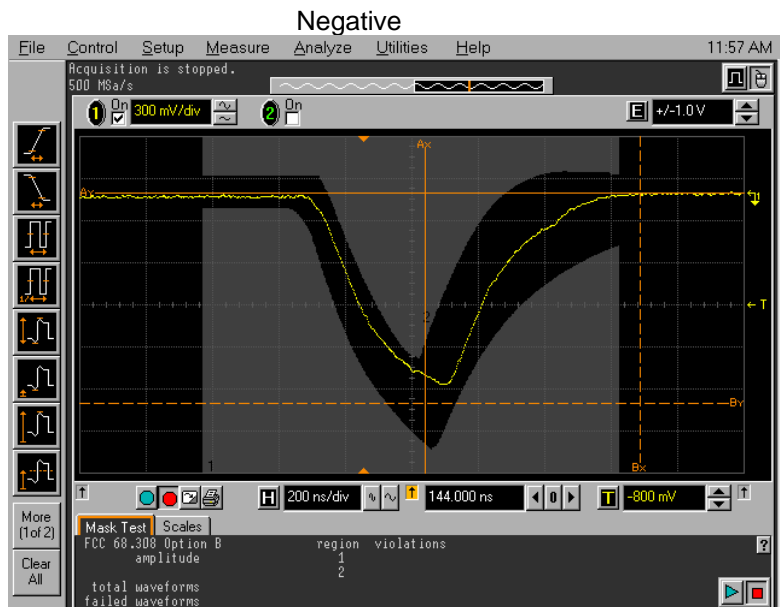
3.2.1. Before stress

3.2. OPTION B
